### Relocating rightside (only) turnbuckle mount hole on the 14.5 head

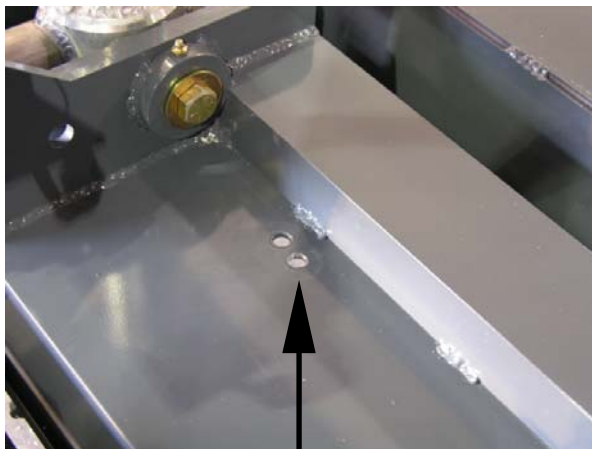
Figure A

The right hand turnbuckle (while sitting in the operator's seat) is mounted at an angle causing excessive wear on the rubber isolators. In order to correct this problem a second mount hole needs to be added to the auger support beam. This procedure can be done in a short amount of time with a drill motor, a 17/32" drill bit, a small pilot bit, a 1/2" box end wrench, socket/ratchet, a center punch and a hammer.

1. Remove the 1/2" bolt, nut and washers from right side (rear only) of turnbuckle and swing turnbuckle up towards the vibrator.
2. Carefully measure from the center of the existing mount hole towards the center of the auger support beam 7/8", making sure the second hole will be in line with the first hole. A second measurement can be taken from the rear of the auger support beam to the center of the existing hole and this measurement can be used as a reference for marking the location of the new hole. (See figure A)
3. Place a center punch on the new hole location and strike a small indent or dimple in the auger support beam.

**\*Tip:** Drill a small pilot hole (approximately half the size of the intended hole) in the auger support beam before drilling the 17/32" hole. This will greatly reduce the possibility of the large bit from walking as the large hole is being drilled.

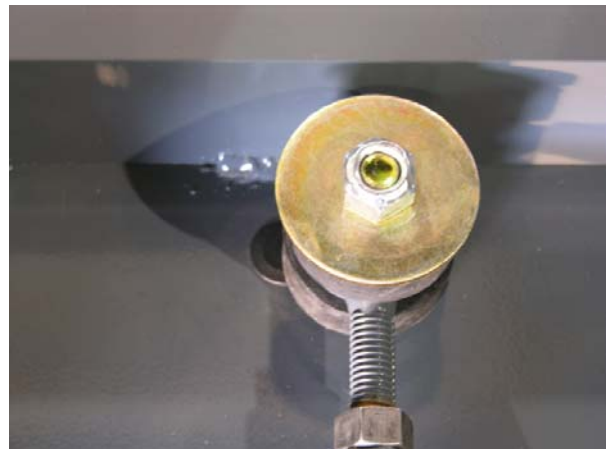
Figure B

New mounting hole

4. Reinstall turnbuckle making sure all bolts are fastened securely and turnbuckle is positioned correctly. (See figure B)
